# Repair Of Cavitation Damage on Impeller

ID: 8299

Industry: Fluid Flow  
Application: SOS-Ships and Offshore Structures

Impeller of Seawater Pump

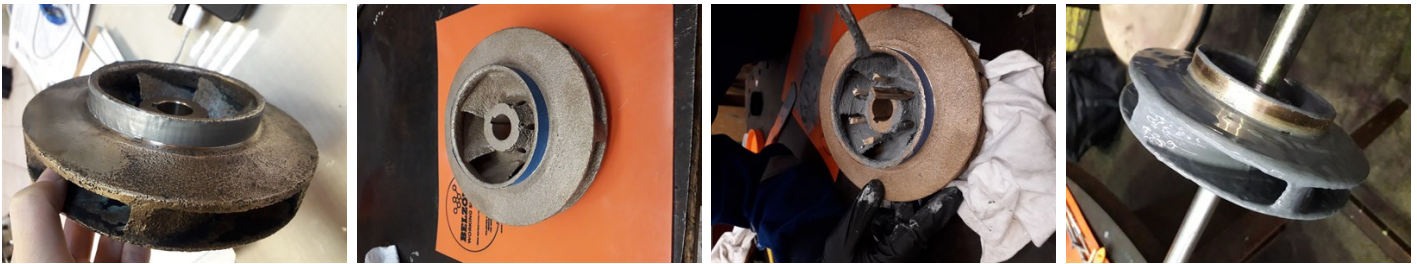
Due to cavitation damage of seawater, impeller has pitting damages on surface and blades causing low efficiency pumping.

- \* Cavitation damaged surface ,
- \* After surface preparation ,
- \* Application of Belzona 1111 ,
- \* Application of Belzona 1321 ,

Application was carried out in accordance with Belzona Know-How System Leaflet SOS-01 and SOS-02. Application surface was prepared with SA2½ grit blasting in workshop. Surface the cleaned with Belzona 9111. Belzona 1111 was used to repair the damaged impeller surface. Belzona 1321 was applied on top of Belzona 1111 and impeller surface within overcoating window, without the need of additional surface preparation.
