# Repair Of Cavitation Damage on Impeller

ID: 8299

Impeller of Seawater Pump

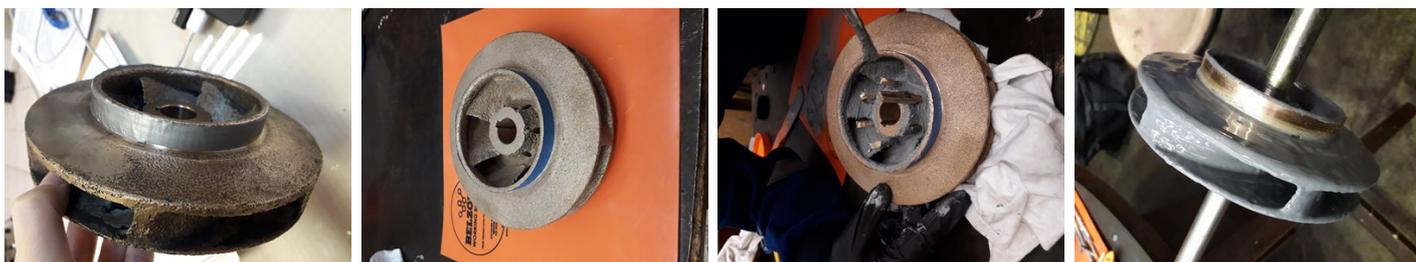
Due to cavitation damage of seawater, impeller has pitting damages on surface and blades causing low efficiency pumping.

- \* Cavitation damaged surface ,
- \* After surface preparation ,
- \* Application of Belzona 1111 ,
- \* Application of Belzona 1321 ,

Application was carried out in accordance with Belzona Know-How System Leaflet SOS-01 and SOS-02. Application surface was prepared with SA2½ grit blasting in workshop. Surface the cleaned with Belzona 9111. Belzona 1111 was used to repair the damaged impeller surface. Belzona 1321 was applied on top of Belzona 1111 and impeller surface within overcoating window, without the need of additional surface preparation.
