CAVITATION DAMAGE IN PUMP REPAIRED

ID: 837

Customer Location: Power Plant / NE Oklahoma
Application Date: March 2007

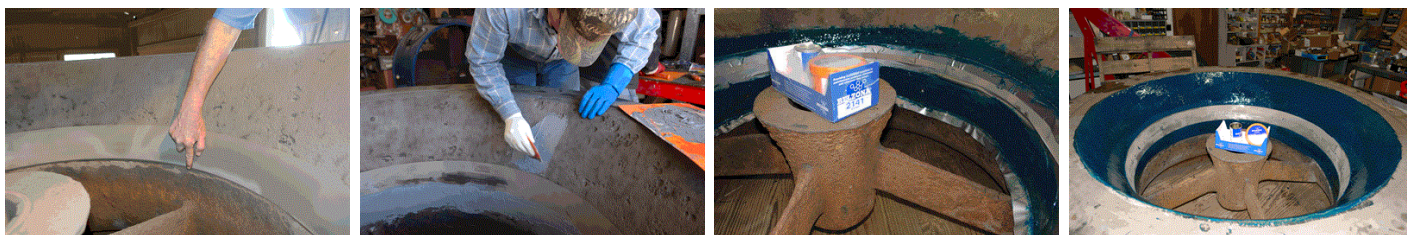
Severe cavitation erosion above and below wear ring. limited time to restore pump.

- * Extent of cavitation damage to suction bell, above and below wear ring ,
- * Repairing damage back to original dimensions ,
- * Repaired surface rebated, taped and half coated with Belzona® 2141 ,
- * Finished job ready for bushing installation then into service ,

Suction bell of pump found to be cavitated during 1 week outage.

Application carried out in accordance with Belzona Know-How System Leaflets CEP-3 and CEP-5. Rebate grooves were cut to terminate coating.

Belzona repair and protective coating combined with 1-week turnaround saved approx. \$15,000 versus purchase of new unit with much longer lead time. Improved resistance to cavitation anticipated.
