CAVITATION DAMAGE IN PUMP REPAIRED

ID: 837

Industry: Power
Application: CEP-Centrifugal Pumps
Substrate: Cast carbon steel (5% Nickel)
Products: * Belzona® 1221 (Super E-Metal) ,
* Belzona® 2141 (ACR Elastomer) ,

Customer Location: Power Plant / NE Oklahoma
Application Date: March 2007

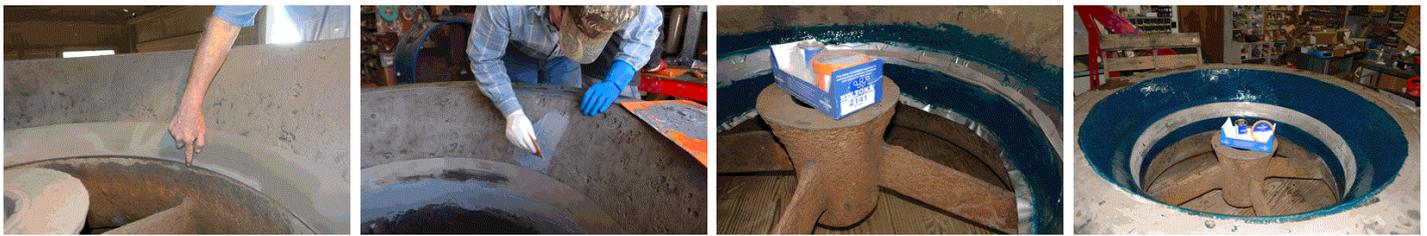
Severe cavitation erosion above and below wear ring. limited time to restore pump.

- * Extent of cavitation damage to suction bell, above and below wear ring ,
- * Repairing damage back to original dimensions ,
- * Repaired surface rebated, taped and half coated with Belzona® 2141 ,
- * Finished job ready for bushing installation then into service ,

Suction bell of pump found to be cavitated during 1 week outage.

Application carried out in accordance with Belzona Know-How System Leaflets CEP-3 and CEP-5. Rebate grooves were cut to terminate coating.
