# Pump Diffuser Repaired Using Belzona 1300 Series

ID: 8500

**Industry:** Power  
**Application:** CEP-Centrifugal Pumps  
**Substrate:** Steel Alloy  
**Products:** \* Belzona 1311 (Ceramic R-Metal) ,  
\* Belzona 1341 (Supermetalgilde) ,

**Customer Location:** Nova Scotia, Canada  
**Application Date:** May 2021

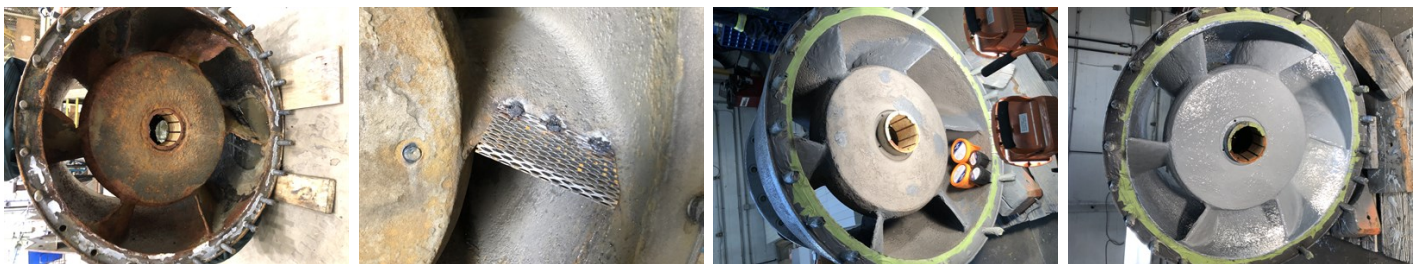
## Problem

Corrosion and erosion from seawater was causing the leading edge of the diffuser vanes to wear away. Approximately 50 to 75mm of the leading edge was gone when this pump component was taken out for service. Weld repairs were not an option due to the steel alloy material.

- \* 1. Pump diffuser in poor condition on vane leading edges and widespread pitting. ,
- \* 2. Diffuser blasted and steel mesh tack welded into place to support Belzona 1311 rebuilding process. ,
- \* 3. Leading edges of the vanes re-built with Belzona 1311. ,
- \* 4. Diffuser fully coated with two coats of Belzona 1341 Supermetalgilde. ,

The application was carried out in accordance with Belzona Know-How System Leaflet CEP-1 to repair the leading edges of the diffuser vanes, and CEP-3 to line the internal surfaces to protect from the effects of corrosion, erosion, cavitation and provide some efficiency enhancement.
