Emergency Flange Repair

ID: 8523

Industry: Marine
Application: VPF-Valves, Pipes and Fittings
Substrate: Steel
Products: * Belzona 1111 Super-Metal and Belzona 9411 Release Agent ,

Customer Location: Seattle, WA
Application Date: June 2021

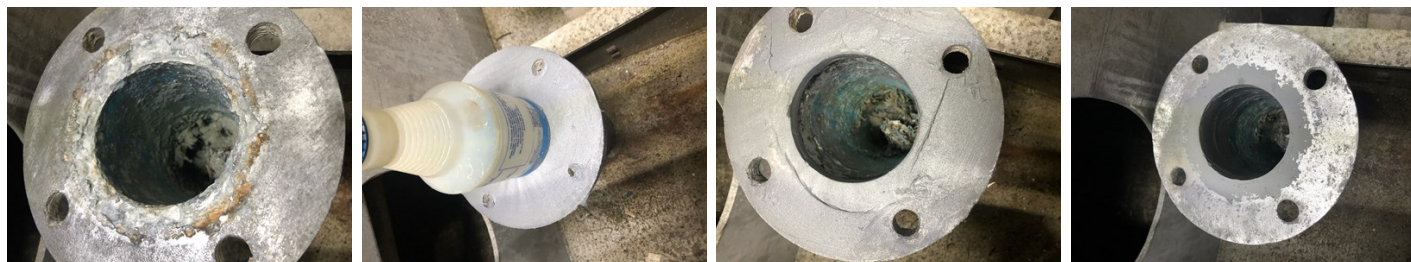
Erosion of the flange face caused ineffective sealing surface

- * 1) Before application ,
- * 2) Casting process ,
- * 3) Cast removed ,
- * 4) Flange sanded and ready to re-install ,

Rebuild flange face using a plastic bottle as a cast

Prepared steel with wire wheel and angle grinder. De-greased and then scrubbed Belzona 1111 onto flange, building up pitted area. Applied Belzona 9411 to plastic bottle. Pressed Belzona 1111 into void around bottle. Sanded excess material back to original dimension.
