Emergency Flange Repair

ID: 8523

Industry: Marine

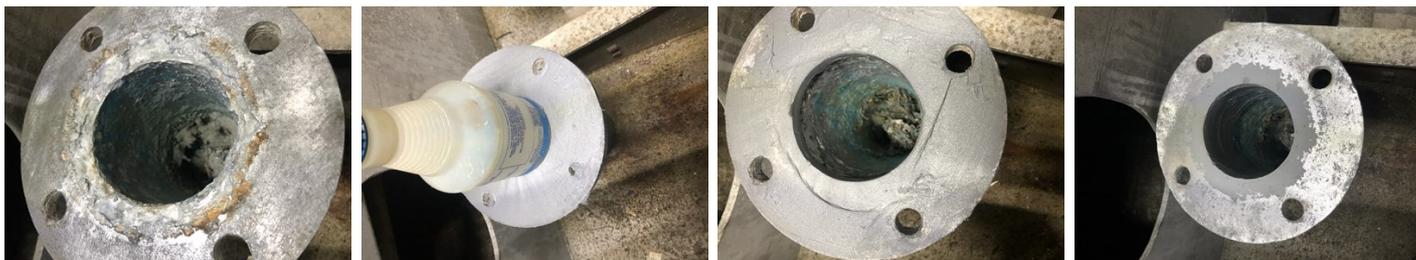
Erosion of the flange face caused ineffective sealing surface

- * 1) Before application ,
- * 2) Casting process ,
- * 3) Cast removed ,
- * 4) Flange sanded and ready to re-install ,

Rebuild flange face using a plastic bottle as a cast

Prepared steel with wire wheel and angle grinder. De-greased and then scrubbed Belzona 1111 onto flange, building up pitted area. Applied Belzona 9411 to plastic bottle. Pressed Belzona 1111 into void around bottle. Sanded excess material back to original dimension.
