# ENGINE REPAIR WITH BELZONA

ID: 854

Application: ENC-Engines and Casings

Application Date: July 2007

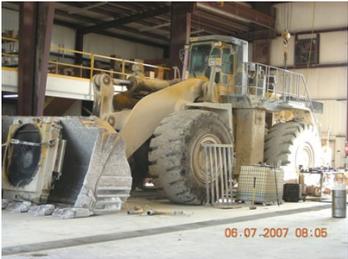
Komatsu 900 loader.

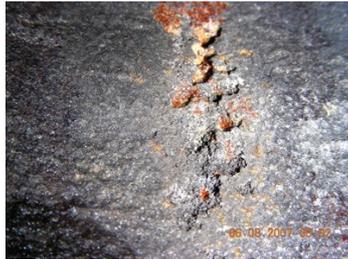
Erosion/corrosion on the cylinder block behind the cylinder liners allowed engine coolant to leak into the lubricating oil causing an engine failure.

Application carried out in accordance with Belzona Know-How System Leaflet ENC-6. Particular attention paid to removing entrained antifreeze before preparing surface and applying Belzona.

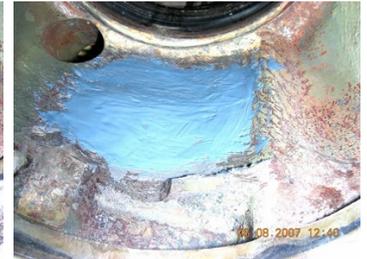
\* Komatsu 900 loader , \* Typical damage , \* Completed surface preparation , \* Finished repair to 1 of the 11 damaged areas ,
