Belzona helps a manufacturer of aeroplane components

ID: 8542

Industry:	Transport
Application:	CEP-Centrifugal Pumps
Substrate:	Cast iron
Products:	* Belzona 1111 (Super-Metal) ,
	* Belzona 2141 (ACR-Fluid Elastomer) ,

Customer Location: Tunisia Application Date: June 2021

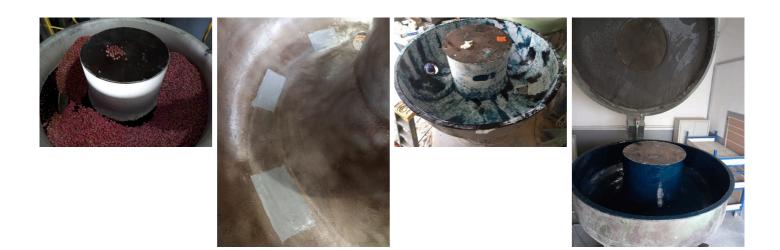
Severely damaged rubber linings. Presence of three cracks after surface preparation.

- * 1 : Damaged rubber linings,
- * 2 : Cracks repair with Belzona 1111 (Super-Metal) and Belzona 9341 (Reinforcement Tape),
- * 3 : Application of first coat of Belzona 2141 (ACR-Fluid Elastomer) with the Reinforcement Tape Belzona 9341,
- * 4 : Completed application,

During inspection, localised damage to the rubber linings caused by wear and abrasion was noted

The application was carried out in accordance with Belzona System Leaflets TCC-1 and CEP-3 Cracks were repaired with Belzona 1111 and 9341, then two coats of Belzona 2141 with reinforcement tape belzona 9341 were applied to replace the damaged rubber linings.
