Belzona helps a manufacturer of aeroplane components

ID: 8542

Application: *CEP-Centrifugal Pumps*

Application Date: *June 2021*

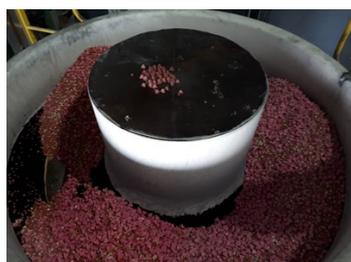
Severely damaged rubber linings. Presence of three cracks after surface preparation.

- * 1 : Damaged rubber linings ,
- * 2 : Cracks repair with Belzona 1111 (Super-Metal) and Belzona 9341 (Reinforcement Tape) ,
- * 3 : Application of first coat of Belzona 2141 (ACR-Fluid Elastomer) with the Reinforcement Tape Belzona 9341 ,
- * 4 : Completed application ,

During inspection, localised damage to the rubber linings caused by wear and abrasion was noted
