HOLED HYDRO TURBINE RUNNER REPAIRED WITH BELZONA

ID: 855

Customer Location: Hydroelectric plant, Vermont

Application Date: January 2007

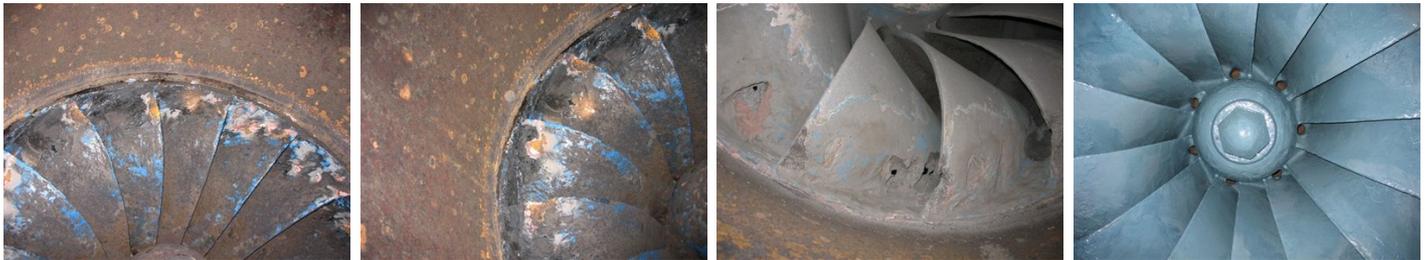
Entrained solids and cavitation caused severe damage to the edges of the runner. Holes and pitting are evident on the runner vanes.

- * Damaged runner with holes ,
- * Damaged runner with holes ,
- * Grit blasted clean and ready for coating ,
- * Finished runner ,

Hydro Turbine runner with severe erosion damage

Application carried out in accordance with CEP-3 & CEP-5. In-situ blast to near white metal finish, rebuilding to fill pits and holes finally overcoating with two coats Belzona® 1341.

Runner replacement would be a several million dollar process involving total removal of the generator sets and dismantling of the penstock. It was not an option. Rebuilding and protection with Belzona will prolong service life.
