HOLED HYDRO TURBINE RUNNER REPAIRED WITH BELZONA

ID: 855

Customer Location: Hydroelectric plant, Vermont

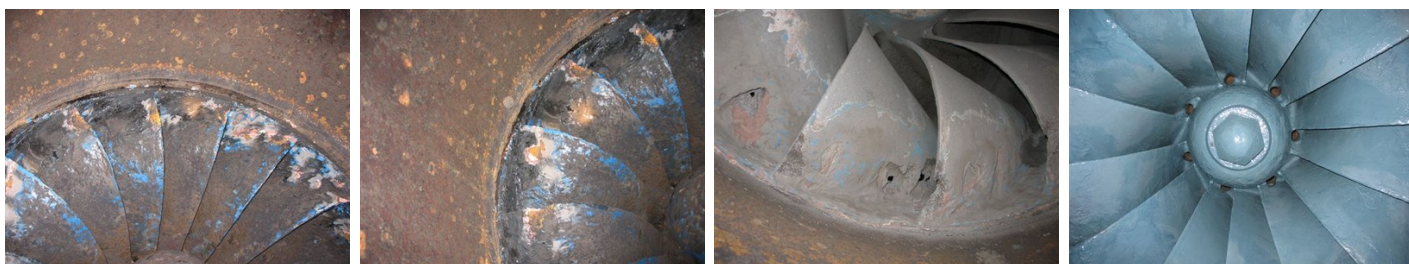
Entrained solids and cavitation caused severe damage to the edges of the runner. Holes and pitting are evident on the runner vanes.

- * Damaged runner with holes ,
- * Damaged runner with holes ,
- * Grit blasted clean and ready for coating ,
- * Finished runner ,

Hydro Turbine runner with severe erosion damage

Application carried out in accordance with CEP-3 & CEP-5. In-situ blast to near white metal finish, rebuilding to fill pits and holes finally overcoating with two coats Belzona® 1341.

Runner replacement would be a several million dollar process involving total removal of the generator sets and dismantling of the penstock. It was not an option. Rebuilding and protection with Belzona will prolong service life.
