crack repair of a gas engine power generator with Belzona

ID: 8554

Customer Location: Hungary
Application Date: 2021

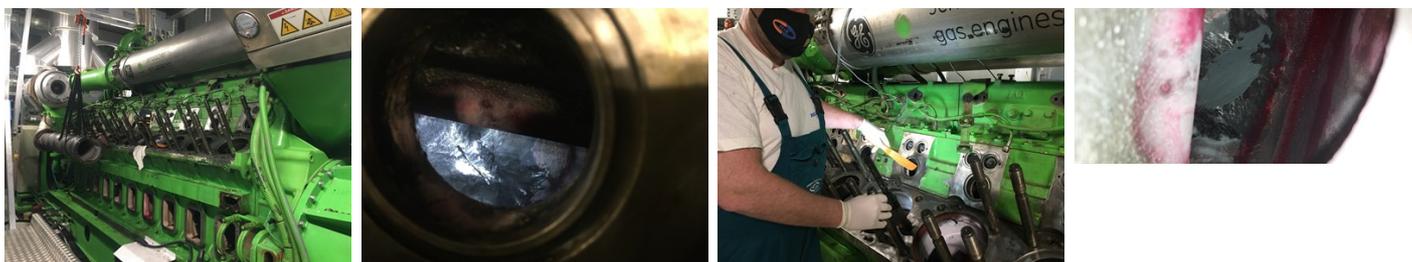
The crack was found deep inside the GE Jenbacher gas engine. The area to be repaired was difficult to access and the regular surface preparation (SA2,5 and 75 microns) was not an option.

- * 1. a total shot of the engine. ,
- * 2. surface preparation through the small hole ,
- * 3. application is in process ,
- * 4. repaired crack ,

The operator noticed a significant loss of the cooling liquid. After a thorough investigation a crack in the cooling liquid chamber was found.

Grinding using a small size electric rotary file was followed by a cleaning and degreasing with 9111 prior the application of the mixed 1212. The paste has been applied with a Belzona spatula through an 80mm (3,15") diameter exhaust hole while another colleague controlled and directed from the other side of the engine.
