crack repair of a gas engine power generator with Belzona

ID: 8554

Application: ENC-Engines and Casings

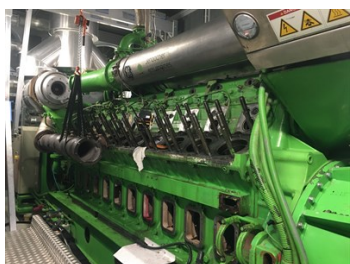
- * 1. a total shot of the engine. ,
- * 2. surface preparation through the small hole ,
- * 3. application is in process ,
- * 4. repaired crack ,
