# crack repair of a gas engine power generator with Belzona

ID: 8554

**Customer Location:** Hungary  
**Application Date:** 2021

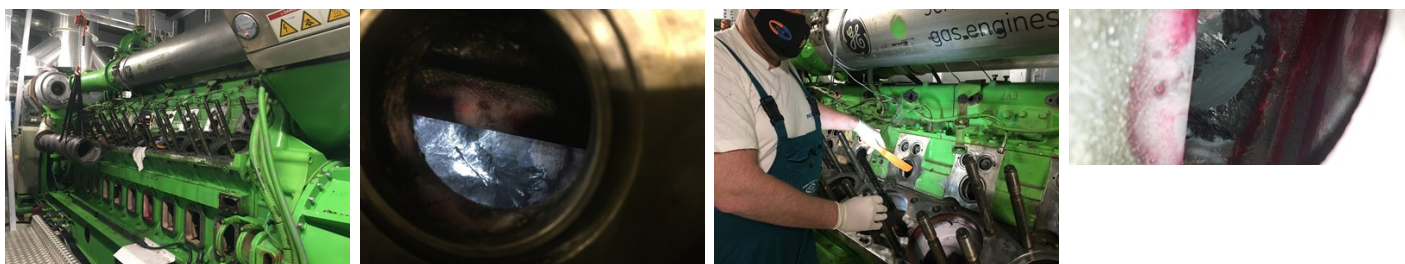
The crack was found deep inside the GE Jenbacher gas engine. The area to be repaired was difficult to access and the regular surface preparation (SA2,5 and 75 microns) was not an option.

- \* 1. a total shot of the engine. ,
- \* 2. surface preparation through the small hole ,
- \* 3. application is in process ,
- \* 4. repaired crack ,

The operator noticed a significant loss of the cooling liquid. After a thorough investigation a crack in the cooling liquid chamber was found.

Grinding using a small size electric rotary file was followed by a cleaning and degreasing with 9111 prior the application of the mixed 1212. The paste has been applied with a Belzona spatula through an 80mm (3,15") diameter exhaust hole while another colleague controlled and directed from the other side of the engine.
