CATERPILLAR 631 ENGINE REPAIRED WITH BELZONA

ID: 856

Customer Location: Magruder Limestone Company, Troy MO
Application Date: June 2007

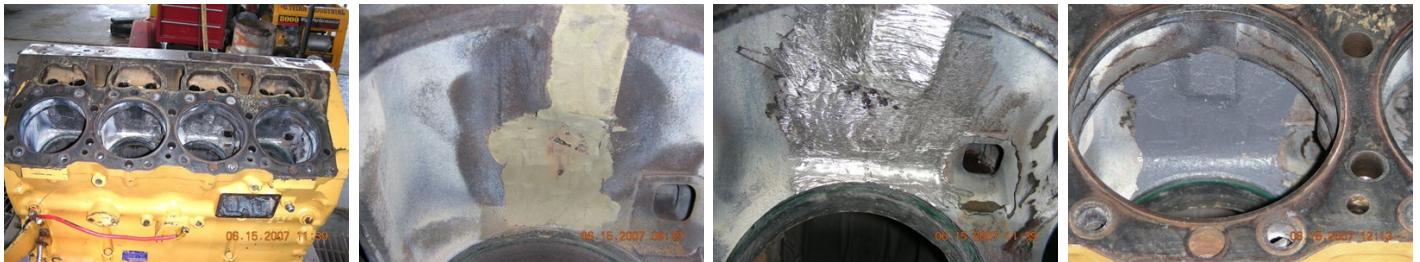
A previous repair with "Brand X" epoxy failed. The owner took it to his own shop & did the work.

* Caterpillar 631 engine block , * Failed "Brand X" repair , * Prepared surface on 1 of the cylinders showing leaks , * Completed repair on 1 cylinder ,

Traces of engine coolant appeared in the lubricating oil test samples indicating erosion in wall of cylinder block

Application carried out in accordance with Belzona Know-How System Leaflet ENC-6.
