# CATERPILLAR 631 ENGINE REPAIRED WITH BELZONA

ID: 856

Customer Location: *Magruder Limestone Company, Troy MO*  
Application Date: *June 2007*

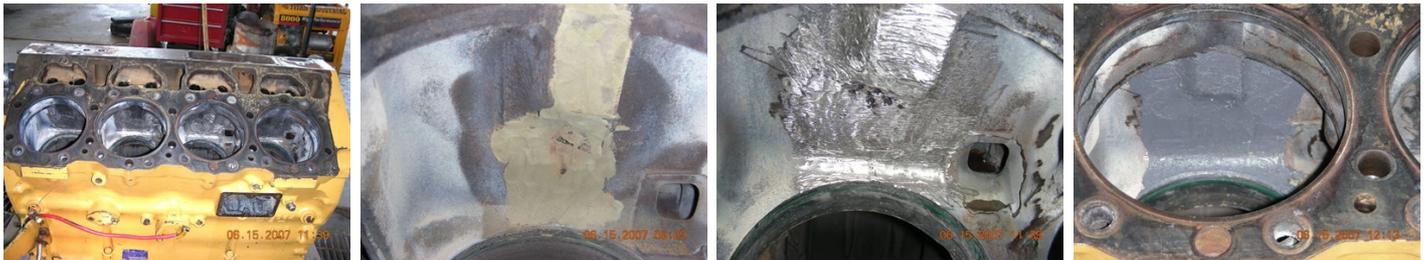
*A previous repair with "Brand X" epoxy failed. The owner took it to his own shop & did the work.*

\* Caterpillar 631 engine block , \* Failed "Brand X" repair , \* Prepared surface on 1 of the cylinders showing leaks , \* Completed repair on 1 cylinder ,

Traces of engine coolant appeared in the lubricating oil test samples indicating erosion in wall of cylinder block

Application carried out in accordance with Belzona Know-How System Leaflet ENC-6.

This is a Caterpillar approved repair for a cavitated engine blocks and has been successfully completed many times on these and Komatsu engines. The Cat dealer declined to do the Belzona repair, claiming that the "brand X" failed repair proved that another such repair couldnt be done & wanted to sell a new engine block.
