Pump case erosion damage repair in gravel mine

ID: 8589

Customer Location: Hungary, Gravel mine
Application Date: 2021.02.20

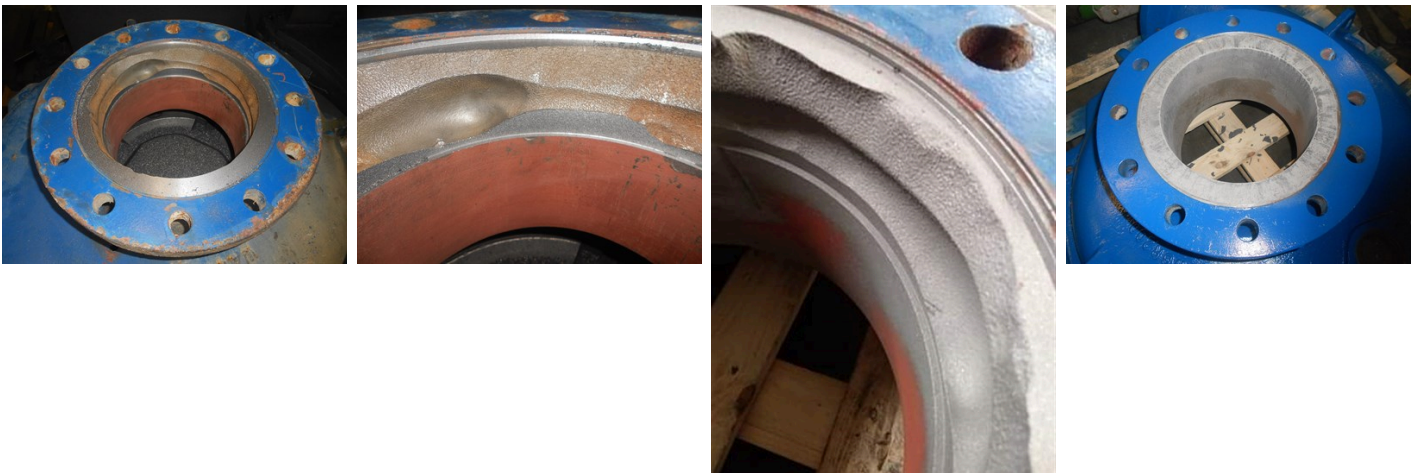
The customers Warman WGR200 suffered from erosion because of the failure of the rubber lining the entrapped solid in the flow found route to the casing surface. The casing material wore until leakage.

- * 1-Deffective casing ,
- * 2-Deffective area ,
- * 3-Deffective area after sand blasting ,
- * 4-Finished application with 1321 top-coat ,

Industry: Mining & Quarrying
Application: CEP-Centrifugal Pumps
Substrate: Cast iron (wear resistant)
Products: * Belzona 1812 was used to build up the whole material loss and subsequently a coat of Belzona 1321 was applied to smooth out the surface, this combination is the best possible solution to prevent or to slow down this erosion mechanism. ,

Hand application according to the CEP-06: For repair of holed/cracked casings
