TURNTABLE TROUBLE SORTED WITH BELZONA

ID: 859

Worn Spline and Gear Drive

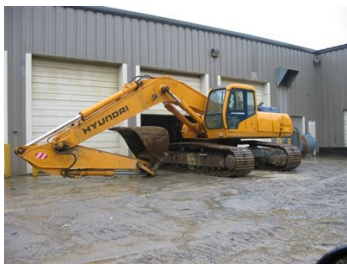
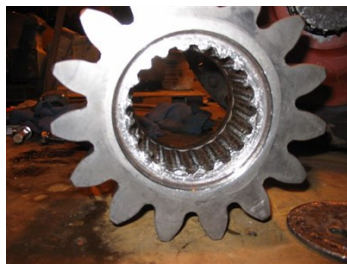
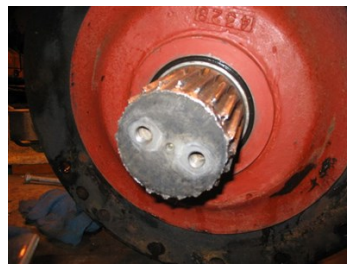
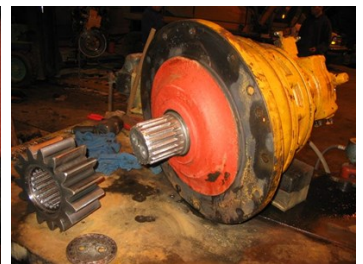
Spline drive and gears were so old and worn that the main deck turntable on the excavator could not operate.

* Excavator unable to rotate Worn gear Worn drive Worn gear and drive ,

Application was carried out in accordance with Belzona System leaflet MPT-5.
