TURNTABLE TROUBLE SORTED WITH BELZONA

ID: 859

Industry: *Mining & Quarrying*
Application: *MPT-Mechanical Power Transmission*

Customer Location: *Heavy Equipment Repair Shop*
Application Date: *May 2006*

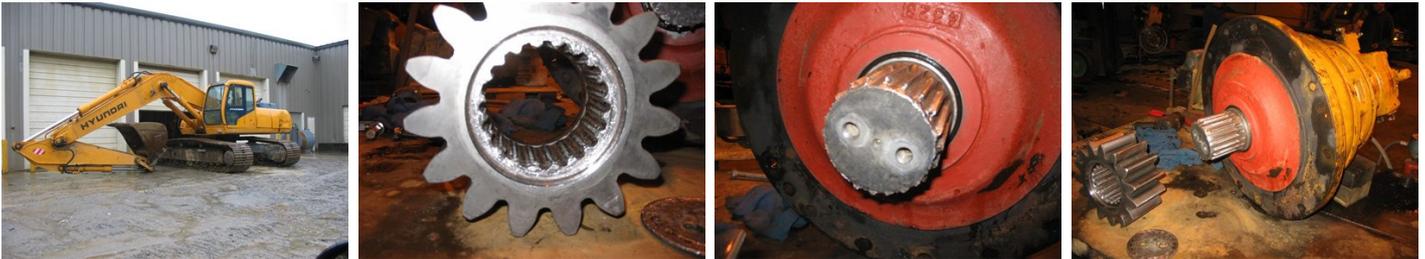
Spline drive and gears were so old and worn that the main deck turntable on the excavator could not operate.

* Excavator unable to rotate Worn gear Worn drive Worn gear and drive ,

Worn Spline and Gear Drive

Application was carried out in accordance with Belzona System leaflet MPT-5.
