# Belzona Repairs Cracked Head

ID: 8593

**Industry:** Chemical & Petrochemical  
**Application:** TCC-Tanks and Chemical Containment Areas

**Customer Location:** Houston

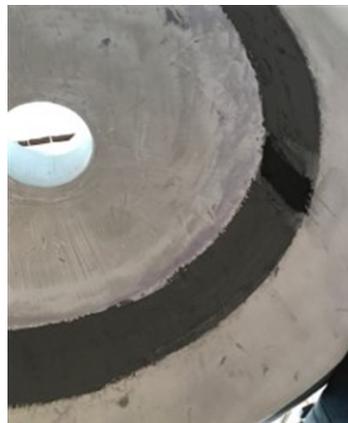
- \* 1. Cracks found with dye penetrate ,
- \* 2. 1st coat of Belzona 1593 and internal SW II after sweep blast ,
- \* 3. External SuperWrap II ,
- \* 4 Final coat of Belzona 1593 ,

A stainless steel head to a pressure vessel has a hairline crack along a weld.

Cracks were found using dye penetrate. All cracks were terminated, holes drilled and tapped 3/8" deep, and set screws installed. Belzona 1511 was used to flush out and rebuild the circumferential weld. Belzona SuperWrap II was applied on both the internal and external surface as a 6 layer system. Belzona 1593 was applied to the internals as a 2 coat system for additional protection.
