Belzona Repairs Cracked Head

ID: 8593

Industry: *Chemical & Petrochemical*
Application: *TCC-Tanks and Chemical Containment Areas*

A stainless steel head to a pressure vessel has a hairline crack along a weld.

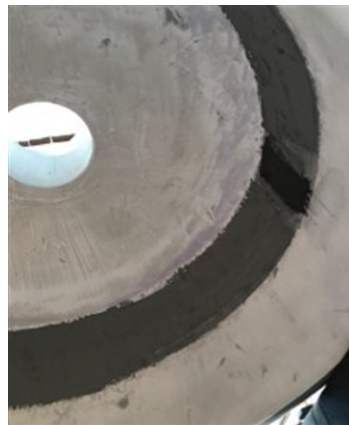
- * 1. Cracks found with dye penetrate ,
- * 2. 1st coat of Belzona 1593 and internal SW II after sweep blast ,
- * 3. External SuperWrap II ,
- * 4 Final coat of Belzona 1593 ,

Cracks were found using dye penetrate. All cracks were terminated, holes drilled and tapped 3/8" deep, and set screws installed. Belzona 1511 was used to flush out and rebuild the circumferential weld. Belzona SuperWrap II was applied on both the internal and external surface as a 6 layer system. Belzona 1593 was applied to the internals as a 2 coat system for additional protection.
