BELZONA REPAIR TO MARINE ENGINE BLOCK

ID: 86

Customer Location: Marine repair shop
Application Date: 1992

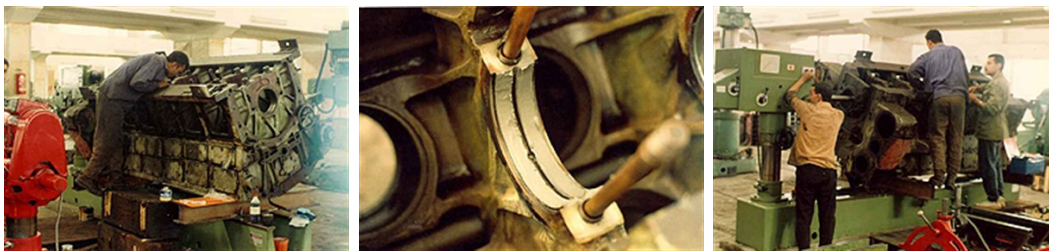
Crankshaft Bearing shells spun in housing causing wear in the housing necessitating rebuilding before new shell bearings installed.

- * Application underway to the engine crankcase ,
- * Belzona® 1111 applied to housing ,
- * Line boring of housings underway ,

Application carried out in accordance with Belzona Know-How leaflet ENC-3.

Replacement crankcase would have cost in excess of \$100,000 and conventional welding repairs could not be guaranteed not to cause distortion. Belzona repairs cost \$1500 and were completed in 3 days.
