BELZONA REPAIR TO MARINE ENGINE BLOCK

ID: 86

Industry: *Marine*
Application: *ENC-Engines and Casings*
Substrate: *Cast Iron*
Products: ** Belzona® 1111 (Super Metal) ,*

Customer Location: *Marine repair shop*
Application Date: *1992*

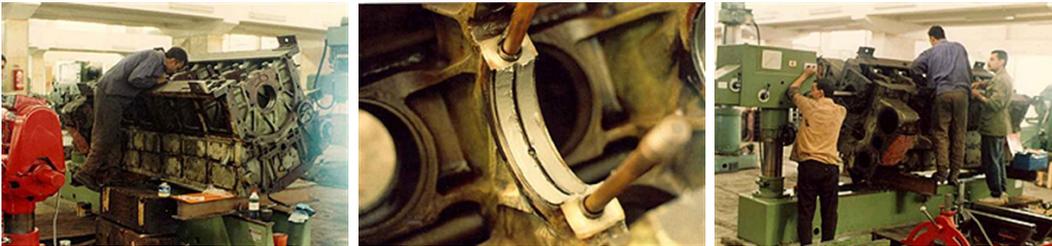
Crankshaft Bearing shells spun in housing causing wear in the housing necessitating rebuilding before new shell bearings installed.

- * Application underway to the engine crankcase ,
- * Belzona® 1111 applied to housing ,
- * Line boring of housings underway ,

Application carried out in accordance with Belzona Know-How leaflet ENC-3.

Replacement crankcase would have cost in excess of \$100,000 and conventional welding repairs could not be guaranteed not to cause distortion. Belzona repairs cost \$1500 and were completed in 3 days.
