# Belzona SuperWrap II Repair on 2in. Elbow - LDHI Transfer Line

ID: 8627

**Customer Location:** Gulf of Mexico  
**Application Date:** April 2021

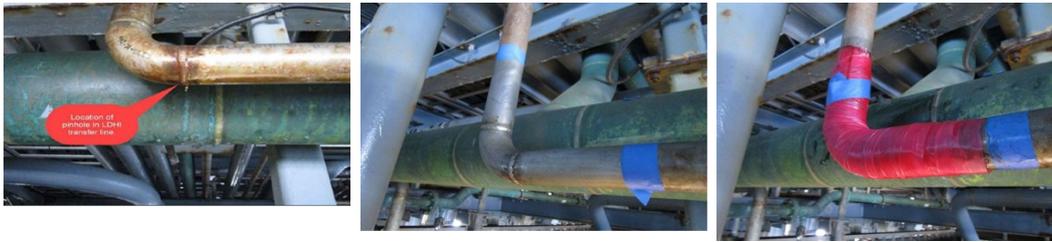
The problem was a pin hole leak that was found on a 2" pipe around the weld seam of an elbow, caused by external corrosion. This was an LDHI transfer line on an offshore platform in the Gulf of Mexico. Operating Temperature is 100F and Design Pressure of 150psi. A quick and compliant repair was desired by client to stop the leak and continue normal operations.

- \* 1. Location of pin hole leak in the pipe. ,
- \* 2. After surface prep was completed. ,
- \* 3. Release Film applied. ,

1. Fill in defect with 9611 to stop leak
2. Power tool clean to bare metal - SSPC-11
3. Repair pitting with Belzona 9611 and Belzona 1161.
4. Apply 3 wraps of SW II - 1982/9381(84mm). 10" total axial extent of repair.
