Belzona SuperWrap II Repair on 2in. Elbow - LDHI Transfer Line

ID: 8627

Customer Location: Gulf of Mexico
Application Date: April 2021

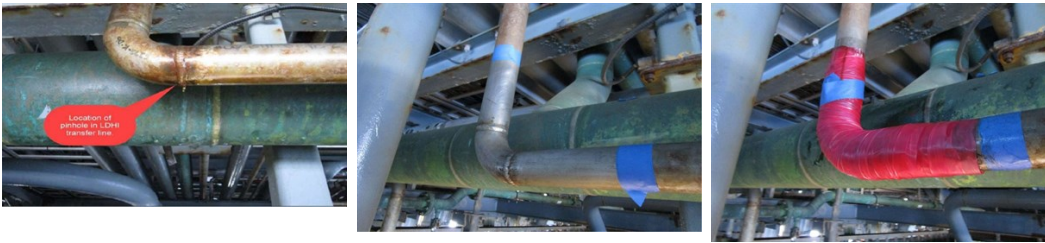
The problem was a pin hole leak that was found on a 2" pipe around the weld seam of an elbow, caused by external corrosion. This was an LDHI transfer line on an offshore platform in the Gulf of Mexico. Operating Temperature is 100F and Design Pressure of 150psi. A quick and compliant repair was desired by client to stop the leak and continue normal operations.

- * 1. Location of pin hole leak in the pipe. ,
- * 2. After surface prep was completed. ,
- * 3. Release Film applied. ,

1. Fill in defect with 9611 to stop leak
2. Power tool clean to bare metal - SSPC-11
3. Repair pitting with Belzona 9611 and Belzona 1161.
4. Apply 3 wraps of SW II - 1982/9381(84mm). 10" total axial extent of repair.
