Belzona stops a leak and strengthens a pipe.

Industry: Application: Substrate: Products: Marine VPF-Valves, Pipes and Fittings Steel * Belzona 9611 , * Belzona 1212 , * Belzona 1111 , * Belzona 9341 , Customer Location: *NW Washington* Application Date: *July 2021*

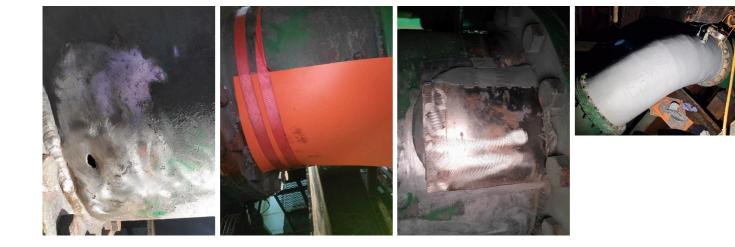
There was a fair-size hole and a large thin-wall area on the elbow of a 30" circulation pipe on a sea vessel. The hole was located where the pipe passed through a bulkhead at the very bottom of the vessel.

- * 1. Close pictures of the hole.,
- * 2. The Belzona mixing board strapped in place. ,
- * 3. Belzona 1212 and doubler plate.,
- * 4. Application complete. ,

The area around the hole was prepared with a grinder and Belzona 9611 was used for the initial plug. Belzona 1212 was then applied with a doubler plate over the Belzona 9611 since water was still present, and a Belzona mixing board was strapped into place over the Belzona 1212 and plate until it was hard. The remainder of the 30" elbow was prepared with a grinder and washed off with solvent. Belzona 1111 was then brushed into the surface, and loaded onto the Belzona 9341 reinforcement sheet and then

wrapped around the pipe from one end to the other. A final layer of Belzona 1111 was applied over the wrap to finish the application.
