Corroded flange area rebuilt with Belzona

ID: 8853

Industry: Chemical & Petrochemical

Application: VPF-Valves, Pipes and Fittings

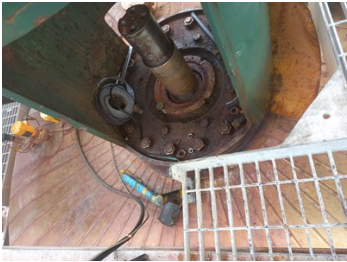
Welding in the area was not feasible due to the proximity of a mechanical seal & the depth of the metal loss

Corroded area around mechanical seal

A mild steel flange section at the top of a vessel had become corroded due to leaking acetic acid. A repair was required to reinstate the lost metal & provide future protection.

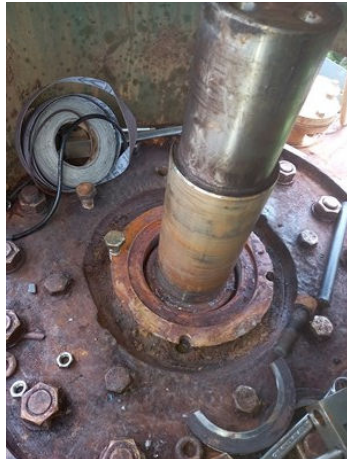
Close up
