Wellhead Leak Repair

ID: 8924

Industry: Oil & Gas
Application: SOS-Ships and Offshore Structures

Customer Location: Gulf of Mexico, USA
Application Date: January 2023

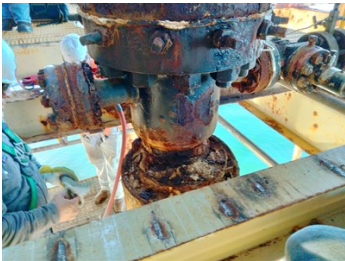
A hole present in the casing did not allow gas lift pressure to accumulate. If the accumulation of pressure is not achieved, then oil cannot be produced.

Original condition of the leaking wellhead.

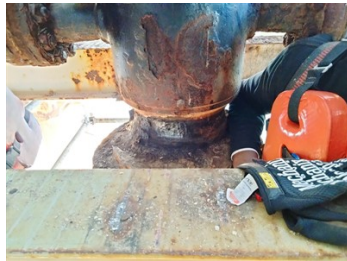
Defect located and prepared for plug with Belzona 9611.

The defect (hole) was plugged with Belzona 9611. Then, the surfaces were rebuilt with Belzona 1121. Finally, the SuperWrap II system was applied to repair the area and offer structural integrity.

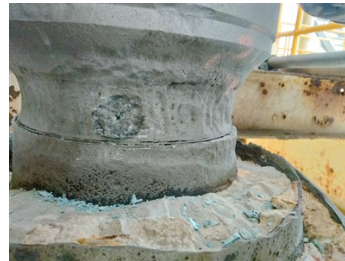
Surface after grit blasting.

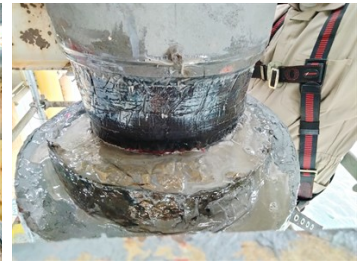
Hole repaired with SuperWrap II.
