TOWBOAT FENDER REPAIR

ID: 8939

Industry: *Marine*
Application: *SOS-Ships and Offshore Structures*

Customer Location: *SEATTLE, WA, UNITED STATES*
Application Date: *June 2022*

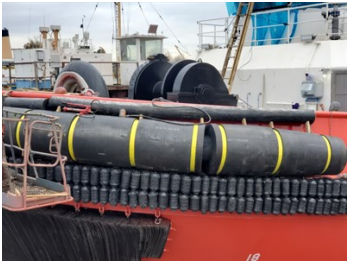
INTERLOCKING FENDER SEAM SEPARATED.
