# TOWBOAT FENDER REPAIR

ID: 8939

Industry: *Marine*  
Application: *SOS-Ships and Offshore Structures*

Customer Location: *SEATTLE, WA, UNITED STATES*  
Application Date: *June 2022*

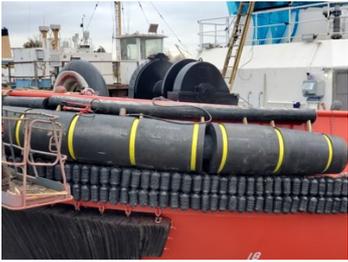
*INTERLOCKING FENDER DELAMINATED.*

INTERLOCKING FENDER SEAM SEPARATED.

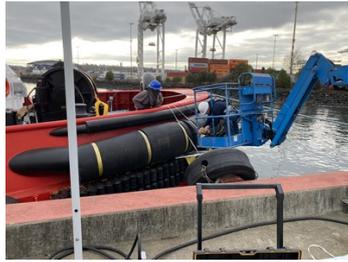
PREPARING THE SUBSTRATE.

SUBSTRATE WAS PREPPED USING LONG SHAFTED DIE GRINDER.

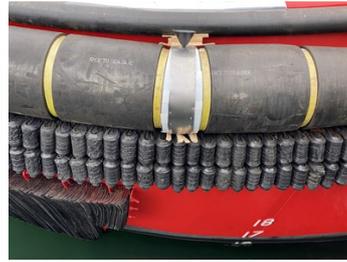
ATTACHING FORM.

SS SCREWS WERE INSTALLED AS ANCHOR POINTS.

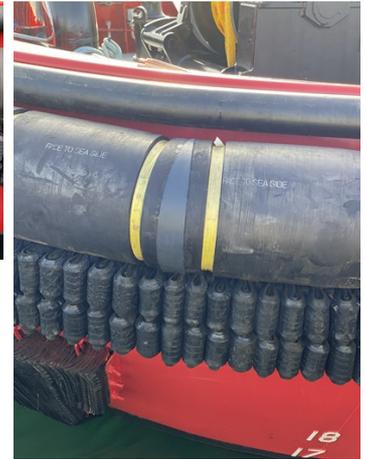
COMPLETED REPAIR.
