# TOWBOAT FENDER REPAIR

ID: 8939

Industry: Marine  
Application: SOS-Ships and Offshore Structures

Substrate: Rubber  
Products: Belzona 2221 (MP Fluid Elastomer), Belzona 2911 (Elastomer QD Conditioner)

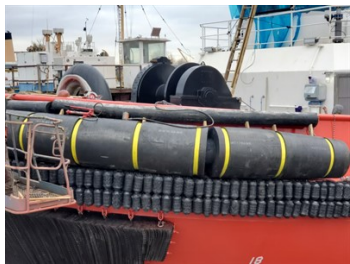
Problem  
INTERLOCKING FENDER DELAMINATED.

FENDER COULD NOT BE REMOVED BY SHIPYARD TO REAPPLY TRADITIONAL ADHESIVE. TIME WAS CRITICAL TO THE SALE OF THE NEW VESSEL.

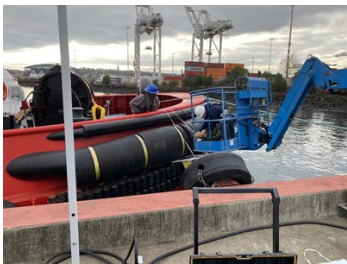
INTERLOCKING FENDER SEAM  
SEPARATED.

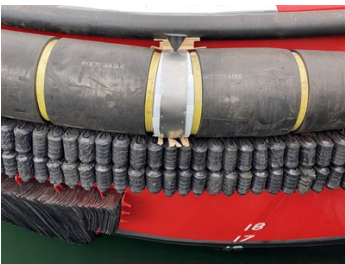
PREPARING THE SUBSTRATE.

SUBSTRATE WAS PREPPED USING LONG SHAFTED DIE GRINDER.

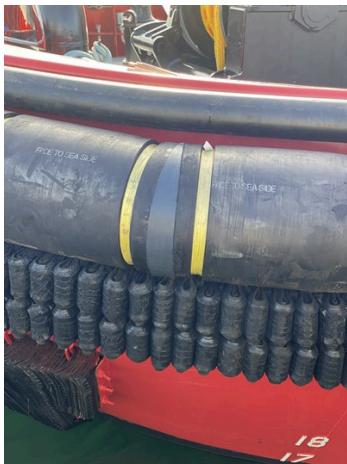
ATTACHING FORM.

SS SCREWS WERE INSTALLED AS ANCHOR POINTS.
