Pump Oil Sump Not All Its "Cracked" Up To Be

ID: 910

Customer Location: US Bureau of Reclamation / Farmington, NM

Application: VPF-Valves, Pipes and Fittings

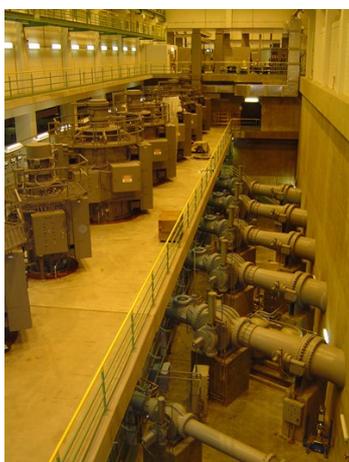
Large oil sump for the shaft bearing at the top of the pump was experiencing cracking from harmonic vibration. As the company that produced the pump was no longer in business and available parts are difficult to find and very expensive, \$1000 of Belzona saved them over \$60,000 worth of replacement parts, labor and downtime. In addition the Belzona solution eliminated the problem from occurring again.

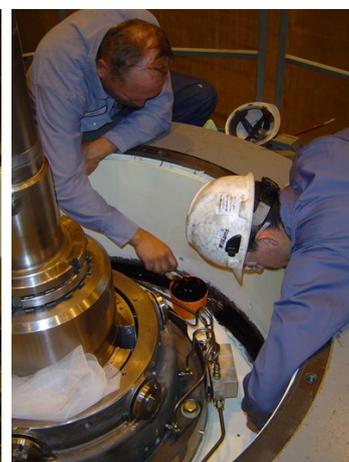
Welding would have stressed the steel causing more cracks to appear. The only way to resist vibration and contain the oil was a flexible surface.

The application was carried out in accordance with a modified version of the Belzona Know-How System Leaflet VPF-3.
