Pump Oil Sump Not All Its "Cracked" Up To Be

Customer Location: US Bureau of Reclamation / Farmington, NM

Application: VPF-Valves, Pipes and Fittings

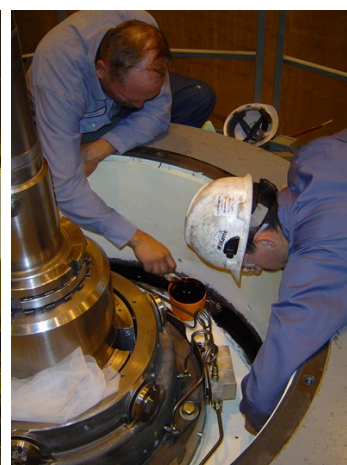
Welding would have stressed the steel causing more cracks to appear. The only way to resist vibration and contain the oil was a flexible surface.

The application was carried out in accordance with a modified version of the Belzona Know-How System Leaflet VPF-3.
