# Metso Fly Ash Pump

ID: 9195

Industry:	Power	Customer Location:	Scotland
Application:	CEP-Centrifugal Pumps	Application Date:	March 2012
Substrate:	Carbon steel		
Products:	Belzona 1121 (Super XL-Metal), Belzona 1812 (Ceramic Carbide FP)

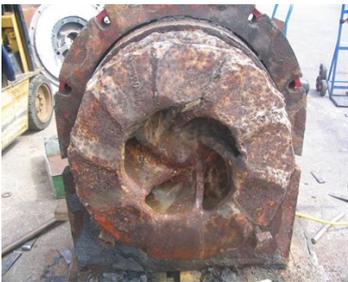
A pump used to transport fly ash was suffering severe erosion & corrosion in service. Due to the harsh conditions pump parts had to be replaced every 6 months.

Damaged parts after service

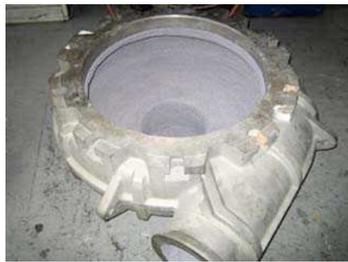
Rebuilding of casing

The pump impeller & casing were first grit blasted & then rebuilt using Belzona 1121. 3-6mm of Belzona 1812 was then applied to provide abrasion resistance.

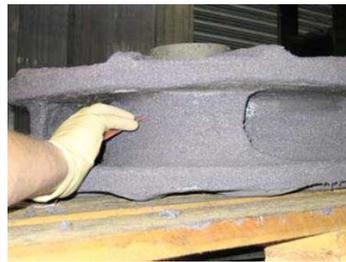
Impeller rebuild &amp; lining
