# Metso Fly Ash Pump

ID: 9195

Industry: Power

Application: CEP-Centrifugal Pumps

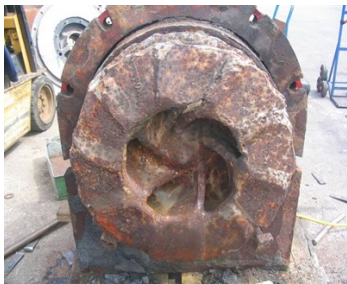
A pump used to transport fly ash was suffering severe erosion & corrosion in service. Due to the harsh conditions pump parts had to be replaced every 6 months.

Damaged parts after service

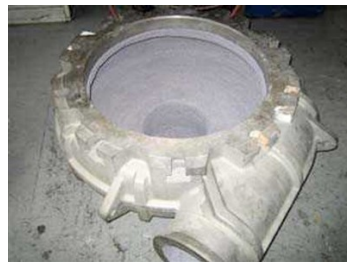
Rebuilding of casing

The pump impeller & casing were first grit blasted & then rebuilt using Belzona 1121. 3-6mm of Belzona 1812 was then applied to provide abrasion resistance.

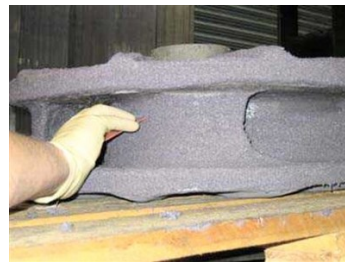
Impeller rebuild & lining

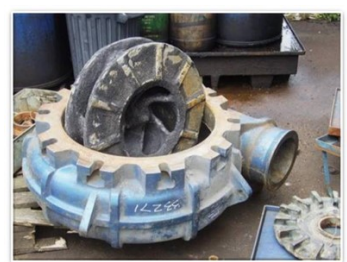
The lining condition after 18 months of service

The original parts were only lasting 6 months. Using Belzona linings took the in service time to over 18 months. These parts could then be relined & put back into service instead of being scrapped.
