BELZONA REPAIRS A BROKEN HYDRO ELECTRIC TURBINE RUNNER

ID: 924

Customer Location: Hydro Electric Plant, U.S.A
Application Date: May, 2007

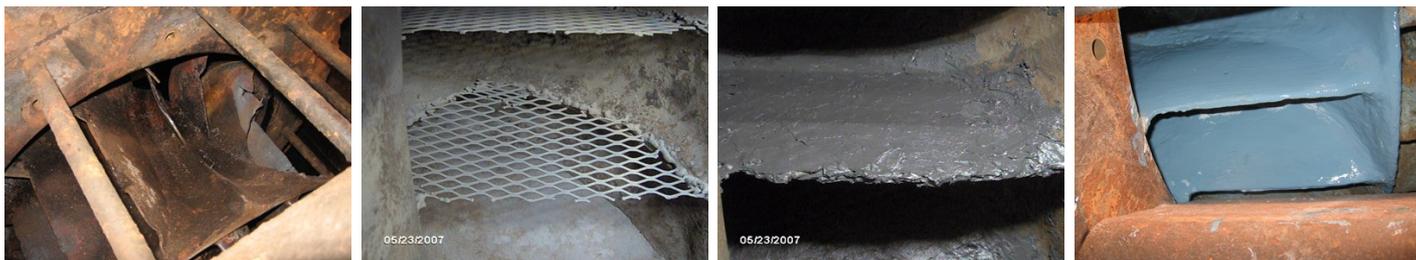
Loss of balance and horsepower.

* Broken runner blade , * Expanded metal tack welded , * Blades rebuilt with Belzona® 1311 , * Completed application after coating runner ,

Wicket gate came loose and fell into turbine breaking three blades on runner.

Application carried out in accordance with the Belzona Know-How System Leaflets CEP-1 & -3. Expanded metal was tack welded in place before rebuilding with Belzona® 1311. Complete runner then coated.
