# BELZONA REPAIRS A BROKEN HYDRO ELECTRIC TURBINE RUNNER

ID: 924

Customer Location: Hydro Electric Plant, U.S.A  
Application Date: May, 2007

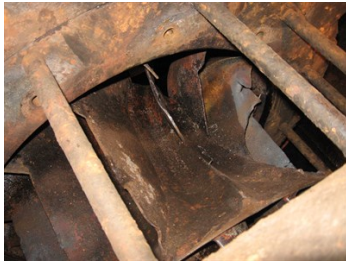
\* Broken runner blade , \* Expanded metal tack welded , \* Blades rebuilt with Belzona® 1311 , \* Completed application after coating runner ,

Wicket gate came loose and fell into turbine breaking three blades on runner.
