Torn conveyor belt repaired with Belzona elastomers

ID: 9345

Industry: *Mining & Quarrying*
Application: *SHM-Solids Handling Machinery*

Customer Location: *Huntsville, Ontario*
Application Date: *April 2023*

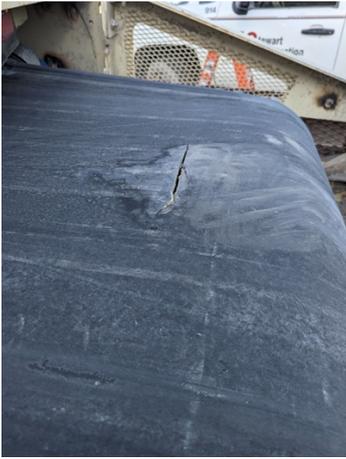
Conveyor belt was ripped and needed repair before being put back in service

Damaged belt

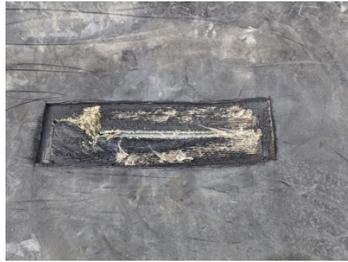
After surface preparation was completed

The ends of the crack were drilled to prevent propagation. Then, the outer layers of the belt were removed and the rubber was properly abraded before application of the Belzona products. The surface was conditioned with Belzona 2911 and then rebuilt with Belzona 2111 reinforced with Belzona 9341

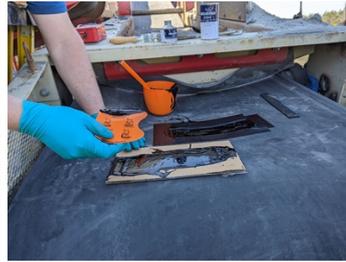
Belzona 2111 application

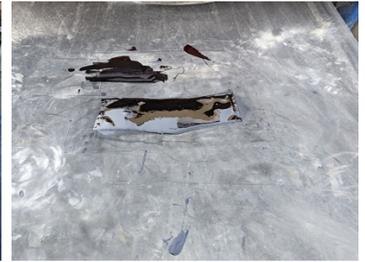
Completed repair

The crew was trained on site and after the repair was completed in less than 1 hour and after a few hours they were able to put the belt back in service. they were very please with the Belzona service and our products.
