# Propeller Repair and Protection

ID: 9409

Industry: *Marine*  
Application: *SOS-Ships and Offshore Structures*

Customer Location: *Seattle WA*  
Application Date: *May 2024*

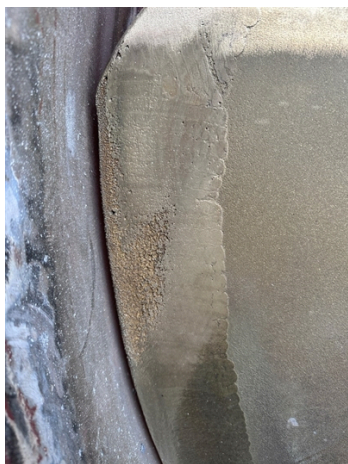
*Cavitation damage on propeller and hub*

Damage to propeller

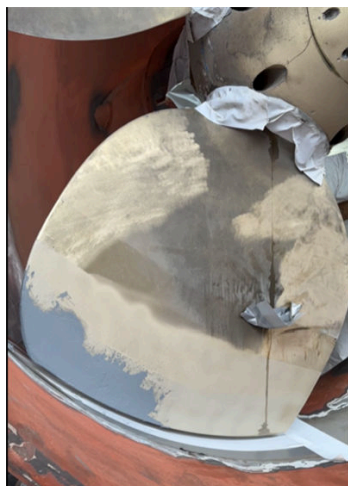
Belzona 1311 applied in areas of cavitation

Belzona 1311 was scrubbed into cavitation pockets then frost blasted after reaching machining stage

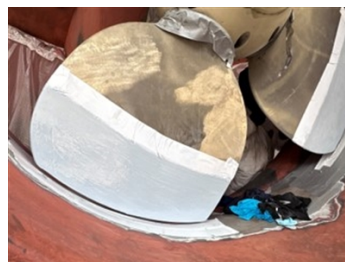
Belzona 1341 grey applied as first coat

1st coat of Belzona 1341 grey was applied at 10mils then a 2nd coat of Belzona 1341 blue was applied at 10mils within the 24hr overcoat window

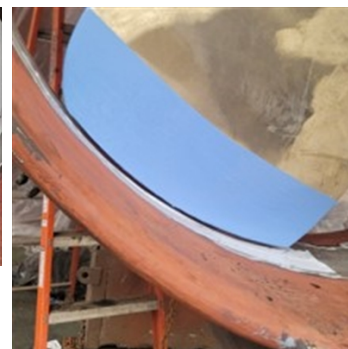
Belzona 1341 blue applied as second coat
