Automotive Engine Block Repair

ID: 9538

Industry:	Transport	Customer Location:	Greece
Application:	ENC-Engines and Casings	Application Date:	September 2024
Substrate:	Aluminum		
Products:	Belzona 1212

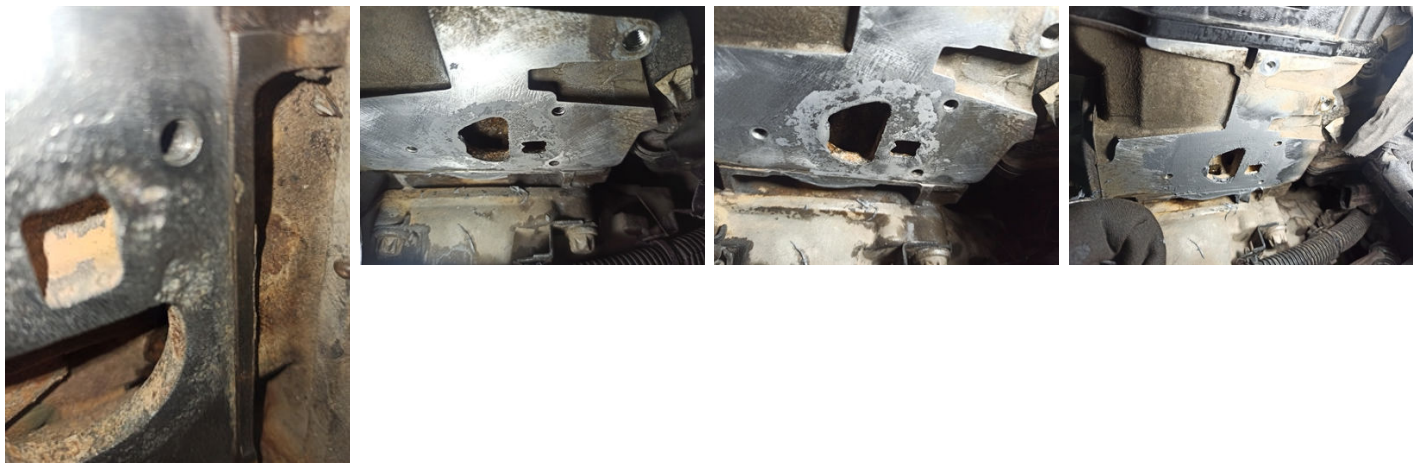
Problem
Cooling liquid leakage from engine block, on an Opel Astra J model, A14XER engine type.

Initial condition with prepared surface Start of application Super Metal Application Repair completed

Workshop cleaned and abraded the surface.
