Automotive Engine Block Repair

ID: 9538

Cooling liquid leakage from engine block, on an Opel Astra J model, A14XER engine type.

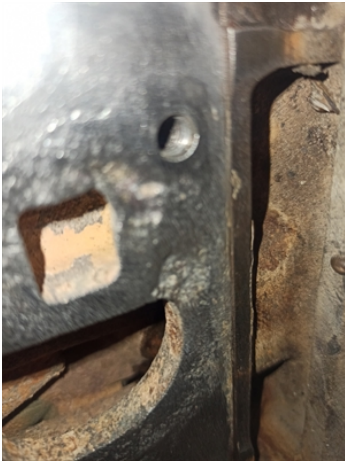
Initial condition with prepared surface

Workshop cleaned and abraded the surface.

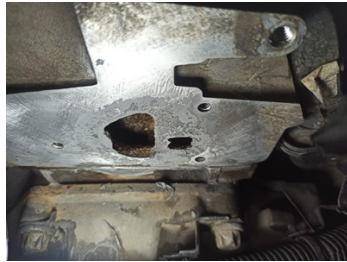
Start of application

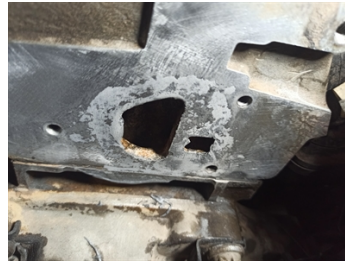
Super Metal Application

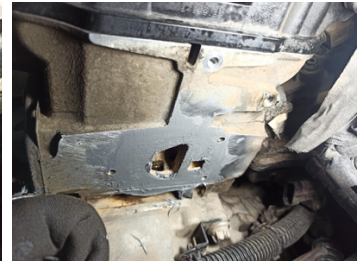
Repair completed
