# Belzona repairs cracked flange

ID: 9574

Industry: *Pulp & Paper*

Application: *VPF-Valves, Pipes and Fittings*

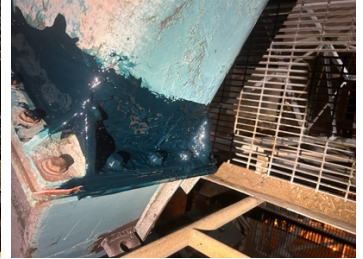
Rebuilt with Belzona 1311

Cracked drill stopped and vee out. Prepares with grinding tools and cracks filled with Belzona 1311 and cloth. Overcoated with Belzona 2141 to provide expansion and contraction protection
