Cracked floor repair and protection

ID: 9577

Industry: Buildings & Structures
Application: FPA-Floor Problem Areas
Substrate: Concrete
Products: Belzona 5231 (SG Laminate), Belzona 5233

Customer Location: Alberta, Canada
Application Date: June 2024

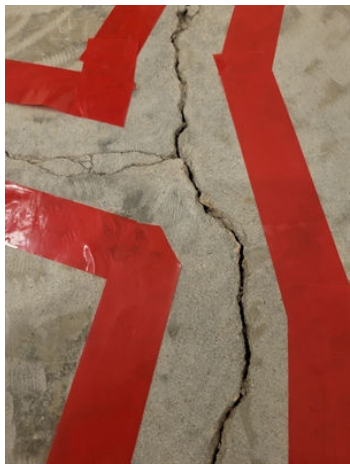
The customer's concrete floor had been cracked due to sub-base ground settlement. Customer wanted the cracks repaired and a protective coating applied for protection and aesthetic purposes.

Repair area was defined.

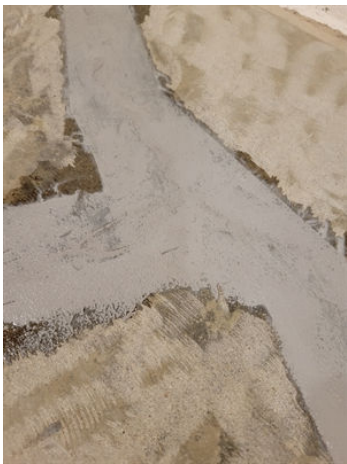
Crack was conditioned with Belzona 4911 and repaired using Belzona 4111.

Belzona 4111 was chosen to repair the concrete cracks to avoid delamination from the concrete substrate, and Belzona 5231/5233 was chosen for the adhesive properties and mechanical strength.

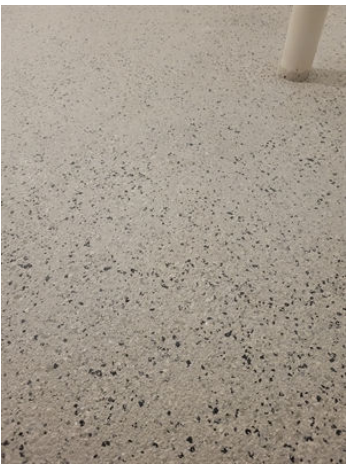
Vinyl flakes applied onto Belzona 5231.

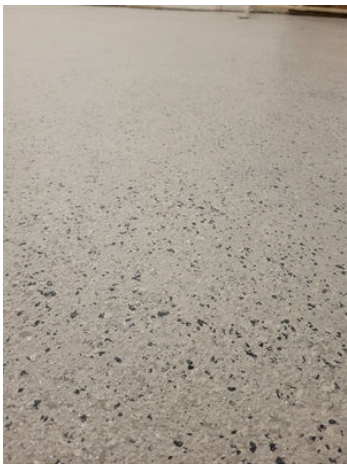
Belzona 5233 was applied as the clearcoat topcoat.
