Oil cooler repair and protection

ID: 9615

Application: HEX-Heat Exchangers

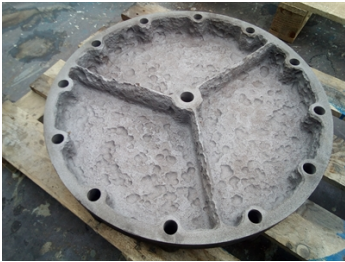
Due to severe corrosion and erosion, the tube sheet and lid were damaged.

Heavily damaged exchanger cover

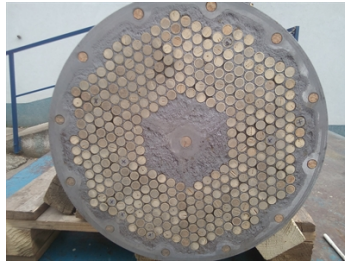
The repair was done using cork plugs.

Surface blasting to the required Sa 2.5 standard with a minimum 75 µm profile. Plugging the ends of coolers with cork plugs. Filling the tube sheet and cover of the cooler with Belzona 1111 Super Metal. Drilling out the plugs + blasting. Application of Belzona 1341 (2 x) in a total thickness of 500 µm.

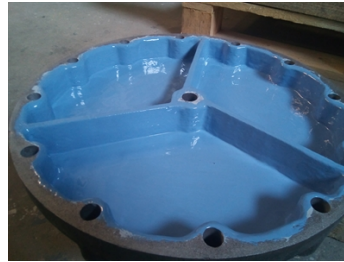
Repaired and protected cover.
