Oil cooler repair and protection

ID: 9615

Application: HEX-Heat Exchangers

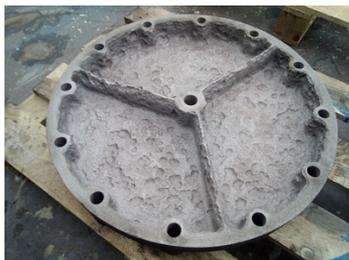
Due to severe corrosion and erosion, the tube sheet and lid were damaged.

Heavily damaged exchanger cover

Surface blasting to the required Sa 2.5 standard with a minimum 75 µm profile. Plugging the ends of coolers with cork plugs. Filling the tube sheet and cover of the cooler with Belzona 1111 Super Metal. Drilling out the plugs + blasting. Application of Belzona 1341 (2 x) in a total thickness of 500 µm.

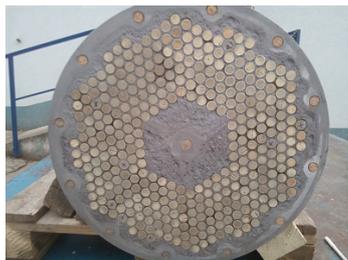
The repair was done using cork plugs.

Repaired and protected cover.
