Fan wheel repair

ID: 9619

Industry: *Cement*
Application: *FBC-Fans, Blowers and Compressors*

Substrate: *Carbon steel*
Products: *Belzona 1812 (Ceramic Carbide FP)*

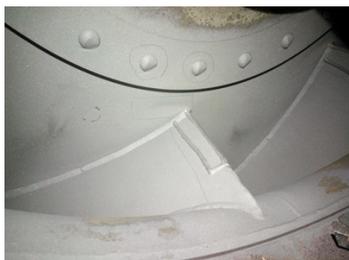
The abrasive material caused severe damage to the wheel

Wheel after blasting

Surface blasting according to the required Sa2.5 standard. Degreasing. Application of Belzona 1812 material on the cleaned surface of the device.

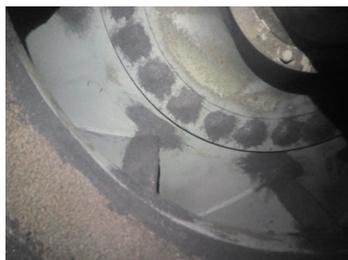
Application of the product Belzona 1812 on the most affected areas

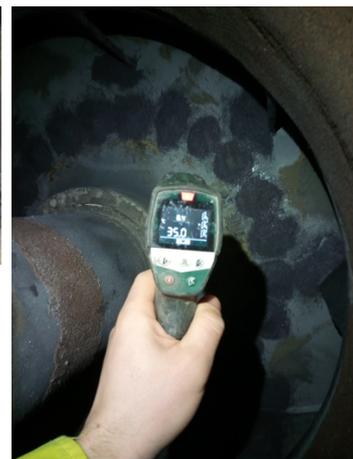
Application of the product Belzona 1812 on the fan blade

Since the repair was carried out in the winter, the fan had to be heated and the temperature had to be controlled.
