Corroded rotor and end covers

ID: 9636

Industry: *Marine*
Application: *CEP-Centrifugal Pumps*
Substrate: *Cast Iron*
Products: *Belzona 1111 (Super Metal), Belzona 1331*

Customer Location: *Houma*
Application Date: *October 2024*

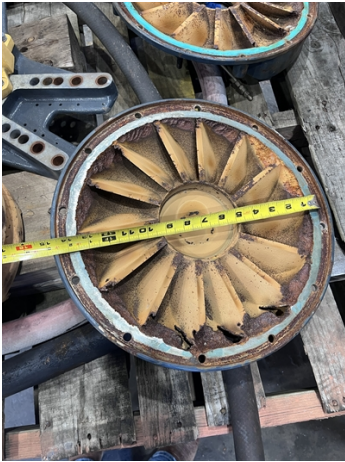
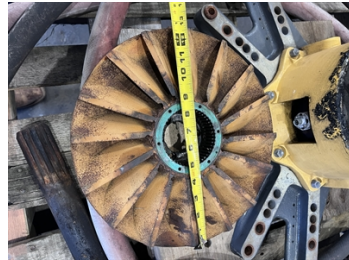
Rotor and end covers corroded due to harsh saltwater environment.

End covers before application. Rotor before application.

Abrasive blasting was performed to create a bonding surface essential for Belzona 1111 to be applied.
