# Concrete stitching to damaged Gearbox plinth

ID: 9875

**Customer Location:** Leicester  
**Application Date:** December 2024

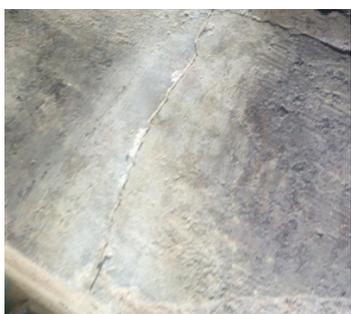
Following the stalling of a very large Ball Mill, the kinetic energy was transferred back to the gear box through the drive assembly. One this energy hit the gearbox, the gearbox kicked back and broke the 10" concrete plinth which the gearbox and drive motor were bolted to, some 30' in the air, above the ground floor  
Structural engineers were consulted, following the advice from the Belzona Area engineer and it was decided that Concrete stitching would provide the solution

Showing crack to plinth

Cross-stitching was carried out to spec and the repair was carried out to all Belzona's Instructions for use and specification sheets  
The only other way to make the plinth safe would have been to remove the drive motor and gearbox and cast a new plinth. The downtime alone would have closed the facility. Belzona were able to offer a solution in under 2 days

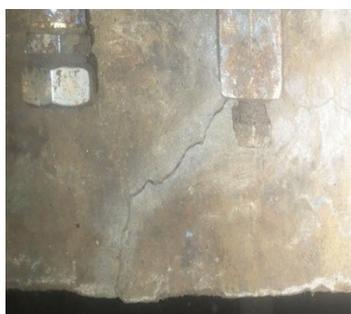
Showing crack on opposite side of plinth

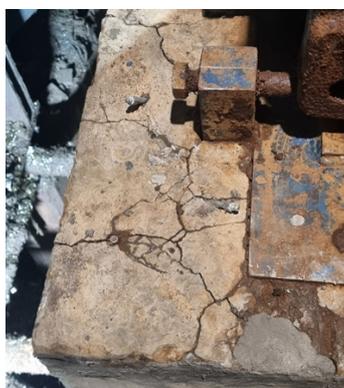
Cracks from above

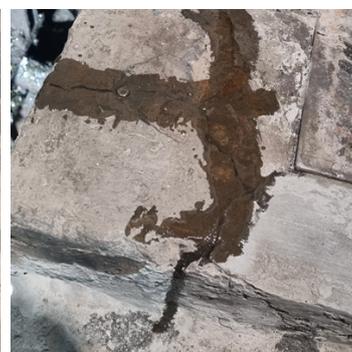
Part way through repairs and concrete stitching, using experienced contractors and Belzona 4151 resins

Using Belzona 4151 in a cartridge, start at the sealed end of the crack and inject the Belzona 4151 into the first port until it appears at the next port in line

Continue this process until all the crack has been completely filled
