Belzona Restores Seawater Cooling Pump Impeller

ID: 10016

Industry: Marine
Application: CEP-Centrifugal Pumps
Substrate: Bronze
Products: Belzona 1111 (Super Metal), Belzona 1321 (Ceramic S-Metal)

Customer Location: Durban - South Africa
Application Date: September 2025

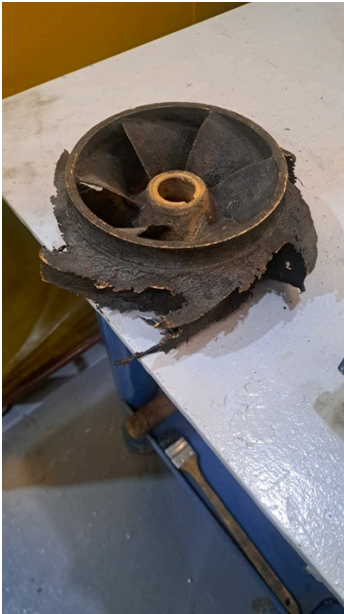
Customer had an emergency docking and sourcing a new impeller would have taken 6 to 8 weeks delivery. Impeller was severely eroded and required urgent rebuilding and coating protection from salt water as this was the vessel's sea water cooling pump.

Damaged Impeller Received From Customer.

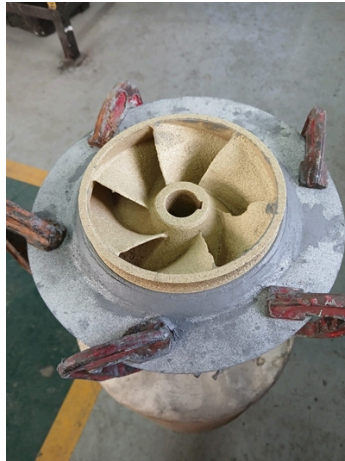
Stainless Plates Cold bonded, Clamped And Shaped To Rebuild Lost Areas.

1. Received impeller, washed with SaltAway and grit blasted clean for inspection and measurement purposes.
2. Top plate made and formed to 260mm OD with ID to suit suction wear-ring OD.
3. Plate and impeller re-blasted prior to being bonded in place with Belzona 1111.
4. A further bottom plate was cut to 260 OD with an ID to suit existing out vanes.
5. Plate and impeller grit blasted and plate bonded in place with Belzona 1111.
6. Sheet metal cut and folded over to rebuild width, length and thickness for damaged vanes rebuild.
7. After blasting, the 6 new vanes bonded in position and the edges and surrounding impeller metal smoothed out with Belzona 1111 and allowed to cure.

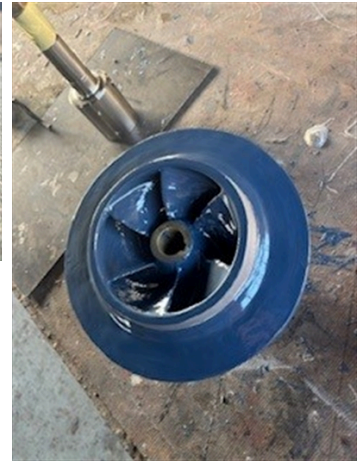
Impeller Completed And Restored.

8. The complete impeller was re-blasted and 2 coats of Belzona 1321 applied throughout.
9. The suction wear-ring was then over-built with Belzona 1111 for machining to correct OD by MSC Technical prior to balancing.
10. After balancing, touch-up undertaken where the balancing damaged the Belzona 1321 coating.
